GALAPAGOS REPORT 2013-2014

MONITORING ENVIRONMENTAL INDICATORS ON ISABELA ISLAND TO PREVENT AND REDUCE POLLUTION

Monitoring environmental indicators on Isabela Island to prevent and reduce pollution

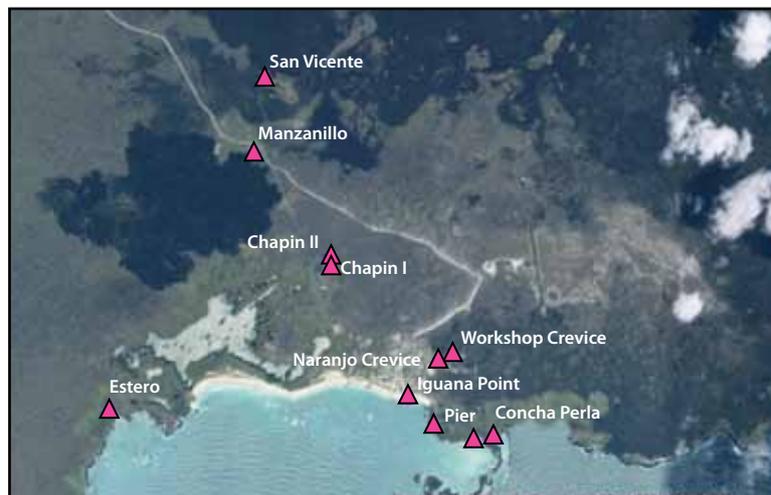
Figure 1. Location of water quality monitoring sites in Puerto Villamil.

The monitoring sites for examining water, soil, and air quality were defined according to the information provided by GADMI, as well as at potential contamination sites (Figures 1, 2 and 3).

Water: To determine the quality of water piped for domestic use, the four water catchment sources were used: Chapin I, Chapin II, Manzanillo, and San Vicente. In some houses, tap water was also examined to identify possible in-transit contamination due to contact with wastewater from leaking pipes. To determine seawater quality at recreation sites, the following sites were selected: the Embarcadero (due to the presence and maintenance of boats) and Estero and Concha de Perla (both tourism sites). It was important to also determine the water quality in the crevice at the municipal workshops (Grieta de los Talleres) because this source provides water to 10 families in the Pedregal neighborhood. Wastewater was also

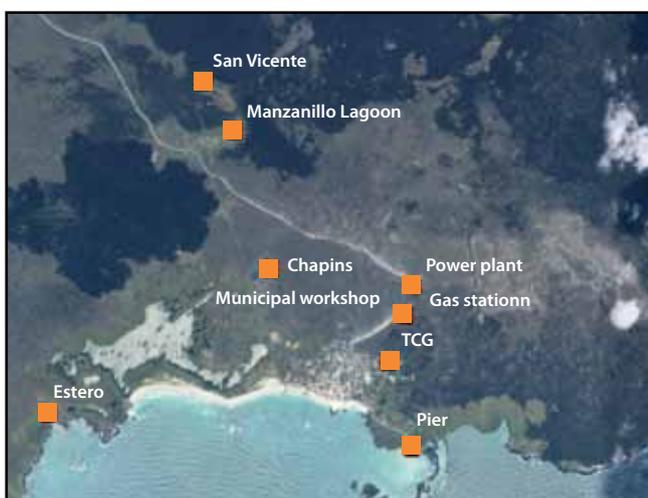
Figure 2. Location of soil quality monitoring sites in Puerto Villamil.

Soil: Soil monitoring was carried out at the following potential contamination sites: municipal workshops, Governing Council workshops, the gas station, the power plant, and the Embarcadero (for potential oil contamination). In addition, soil samples were collected from the four water catchment sources. Samples were also taken from the mud that accumulates at the sewage discharge site near the treatment plant. In total, two series of soil samples were collected over a period of four months. The samples were analyzed in a certified laboratory for the following: general parameters, heavy metals, and hydrocarbons (TPH).

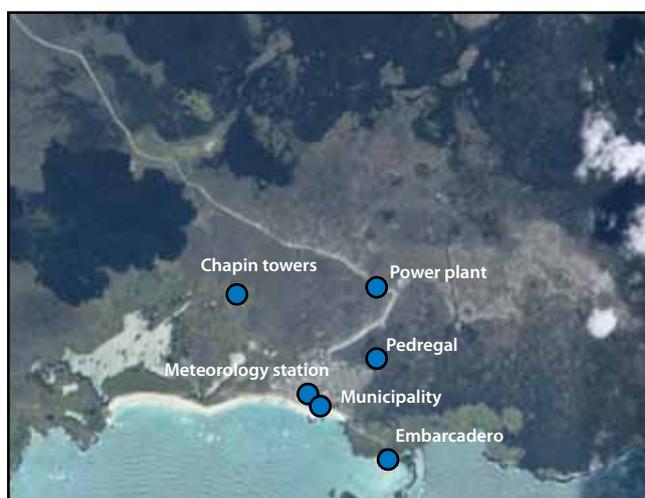
Figure 3. Location of air quality monitoring sites in Puerto Villamil.

Air: Air quality was monitored at five passive stations during a 30-day period: the power plant, the Embarcadero, municipal workshops, Governing Council workshops, and the municipal plaza. The

towers of Chapin I and a weather station at the old police station were used as control sites. Air quality was determined by measuring the following: general parameters, SO_x, NO_x, PM, O₃, and benzene.
